# Amazing Results

Replace delaminating epoxy flooring in kitchen area of hospital

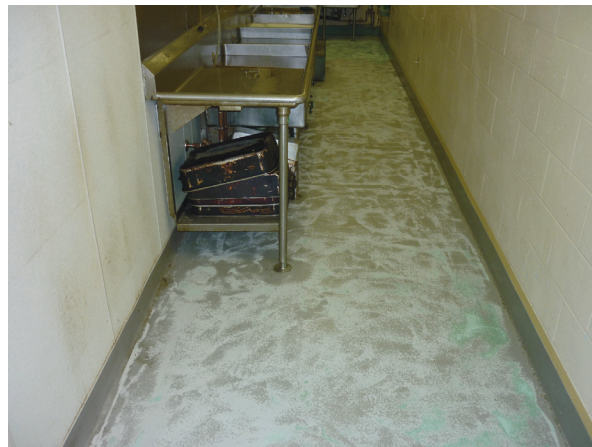
Before

The kitchen area was tented off and all equipment was moved to the other half off the kitchen so it could remain operational. The floor was ground utilizing diamond grinders equipped with HEPA filtration to eliminate dust contamination.

Then the floor was coated with Vikon 9086 series eco friendly, 100% solids, zero solvent, zero VOC polyurea coating. An appropriate amount of non-skid aggregate was added to promote safety, but also allowed for easy cleaning. The process was repeated on the other half of the kitchen.

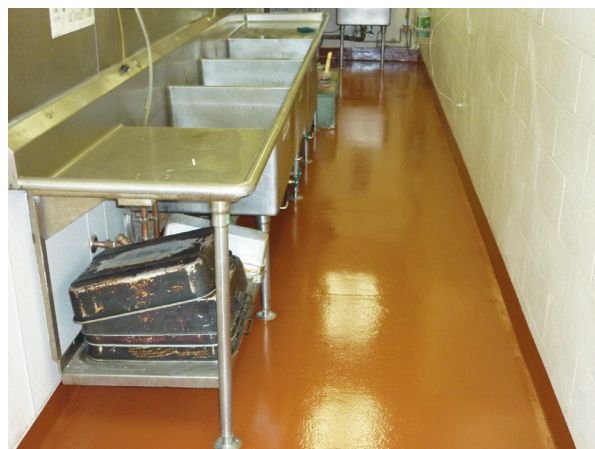
After

Rooms were prepared and repaired using our Vikote series Polyurea self-leveling filler. A three-coat system of the Vikote products was applied along with a vertical formula to provide a 12 inch cove base in both areas.
