Amazing Results

Install a two-coat clear floor coating at newest store location with 8,000/SF

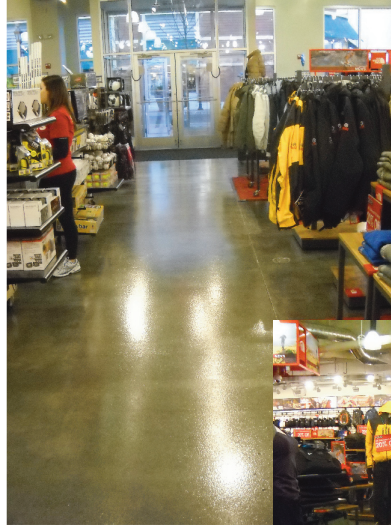
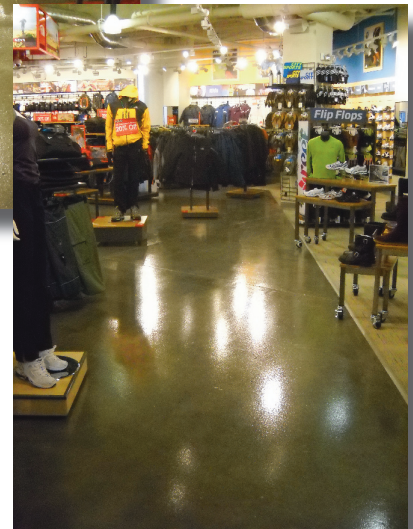
Satisfied customer that now has a high performance, highly decorative, (the floor highlights the "Olive" hue of the substrate as seen in these photos) low maintenance floor delivered in time for the grand opening! Innovative Formulations – Outstanding Technical Support – Excellent Execution. That Matters!

Treated the concrete with an emulsifying solution while grinding and burnishing the fibers that rose through the process. Independent ASTM tests for hydrostatic pressure revealed that the slab was subjected to 8.4 LBS per 1,000 SF/24hours of hydrostatic pressure when any conventional coating would fail at 3.4 LBS of hydrostatic pressure.

Our groundbreaking and "job saving" Vikote Polyurea primer formulation, which in addition to being an eco-friendly coating, is able to withstand hydro pressure up to 12lbs per 1,000 SF/24hours.
