# Amazing Results

Repair recently renovated executive dining area floor

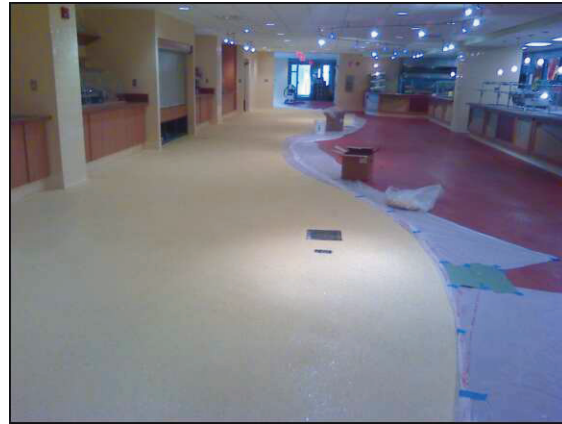
The floor was made of some type of rolled mat material to give it the look almost of a bamboo floor. It was failing in many places, faded in areas exposed to sunlight, and was scuffed and gouged by normal use of the facility

Before

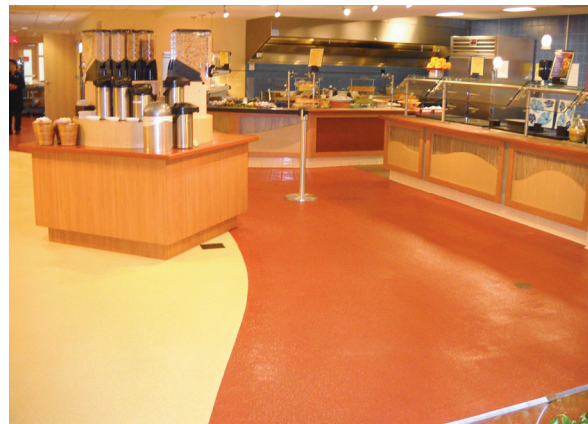
Installation personnel were off premises by 8pm Sunday. The end result was a high gloss, easily maintained durable floor. Where high performance, decorative, zero solvent, zero VOC floor coatings are required due to quick “return to service” mandates, Vikon products are the solution of choice.

After

The red floor was then laid back down and the demarcation line was traced and replicated exactly. The Saturday morning crew applied a base coat of beige Vikote series 9050 polyurea, broadcast vinyl chips, and one coat of clear polyurea to seal the application. The next shift then repeated the preparation process to the red section. On Sunday morning the crew repeated the three coat process on the red section and 3 hours later applied a 4th coat consisting of Vikote Clear to achieve a combined 20 mil thick application.
